**FIELD ACTIVITIES REPORT
Mine Adit Entry**

**RED AND BONITA MINE SITE
Silverton, San Juan County, Colorado**

TDD No. 1008-01

January 20, 2012

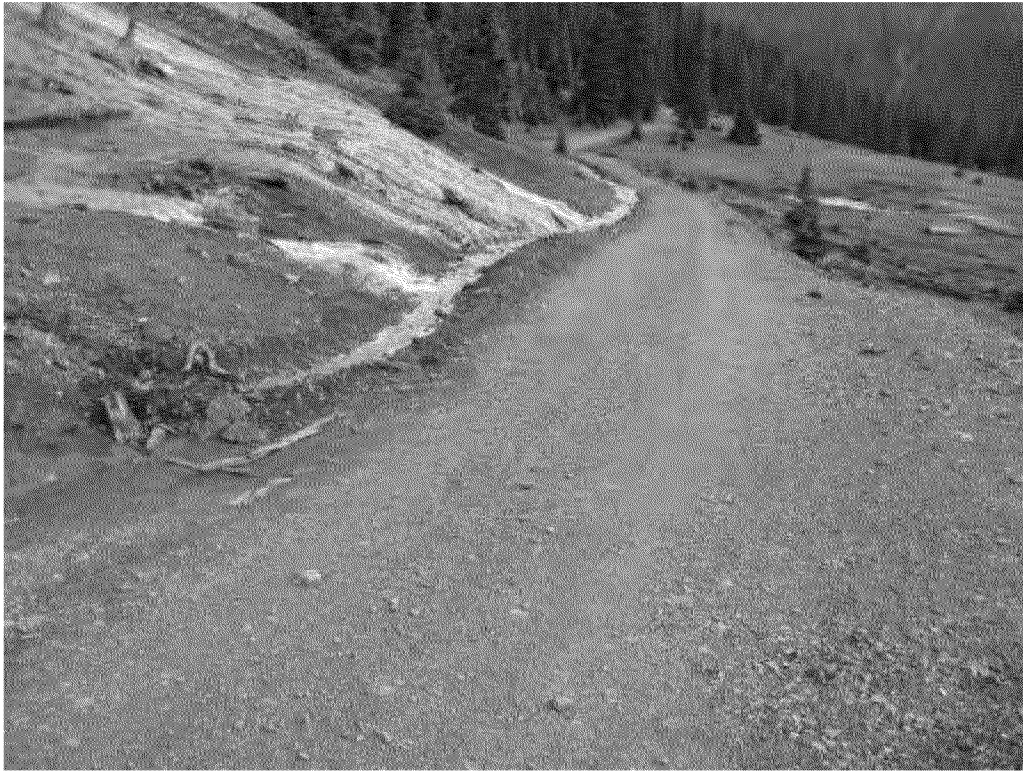
PHOTO 1 8-23-2011

Field conditions prior to adit entry activities. South view along CR 53. Toe of dump on left. See also Photo 2.

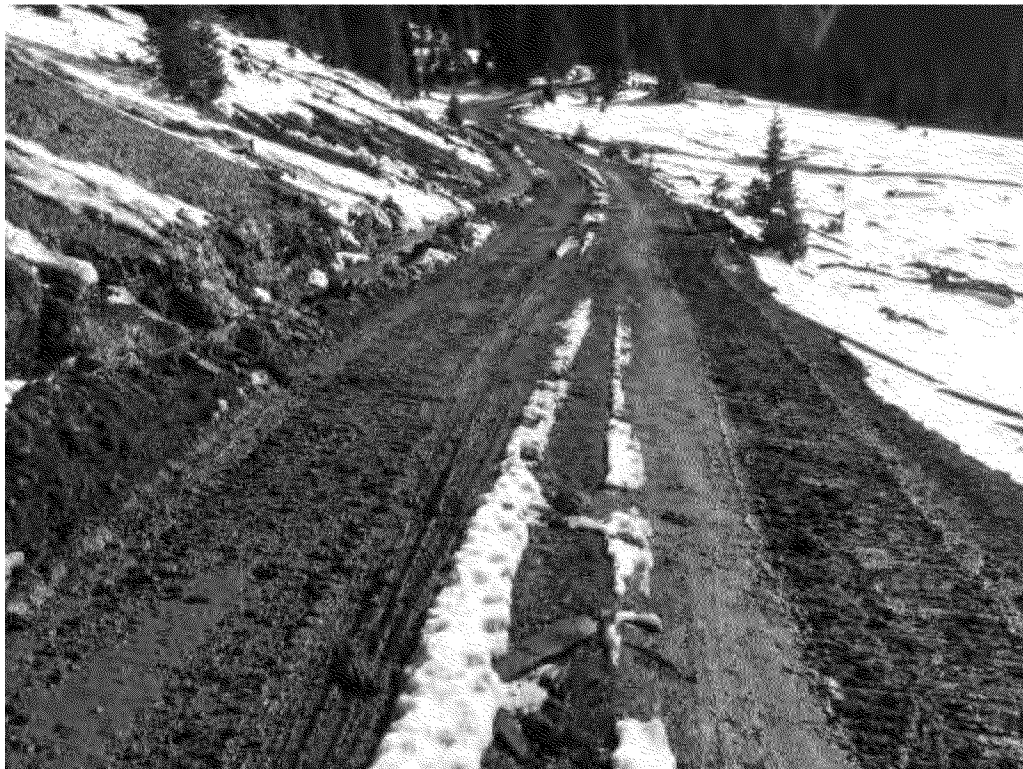
PHOTO 2 10-13-2011

Field conditions after adit entry. View south along CR53, toe of dump on left. See also Photo 1.

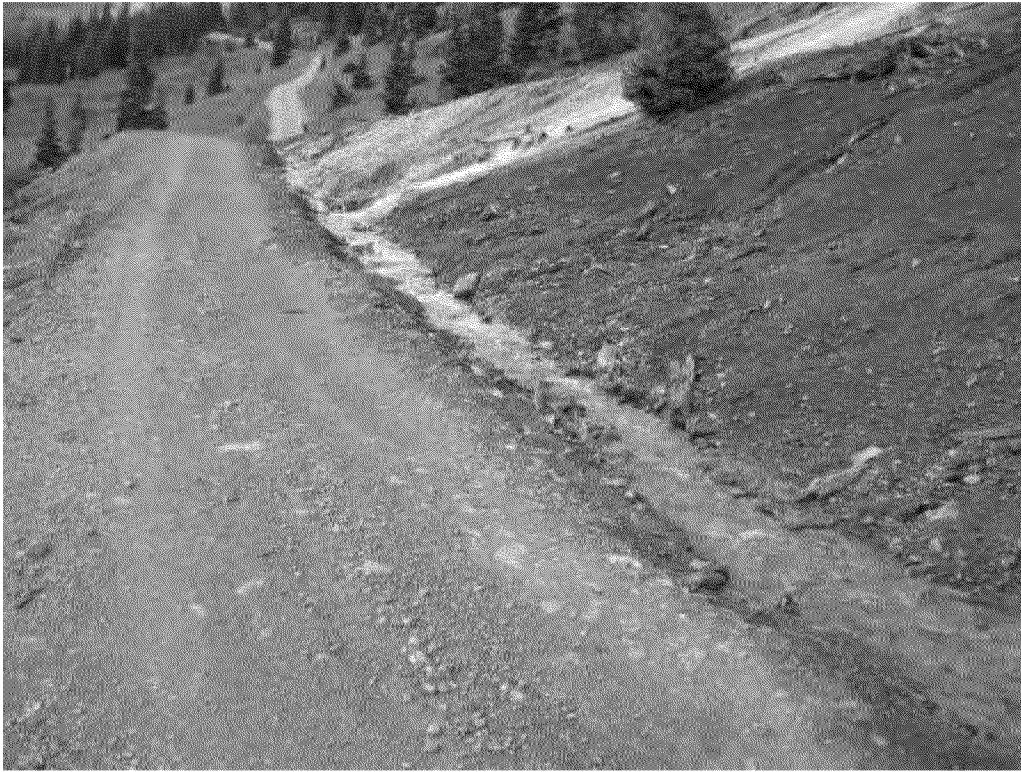
PHOTO 3 8-23-2011

Field conditions prior to adit entry activities. View northward on CR53, toe of dump on right. See also Photo 4.

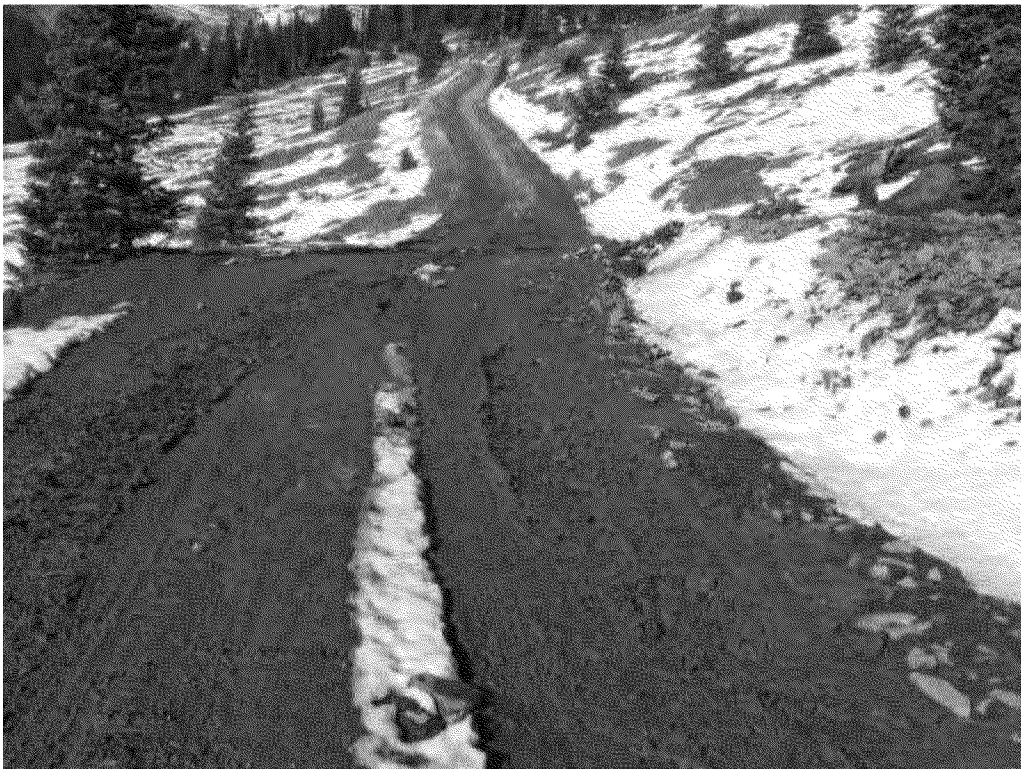
PHOTO 4 10-13-2011

Field conditions after adit entry. View north on CR53, manifold filter bag area on right. See also Photo 3.

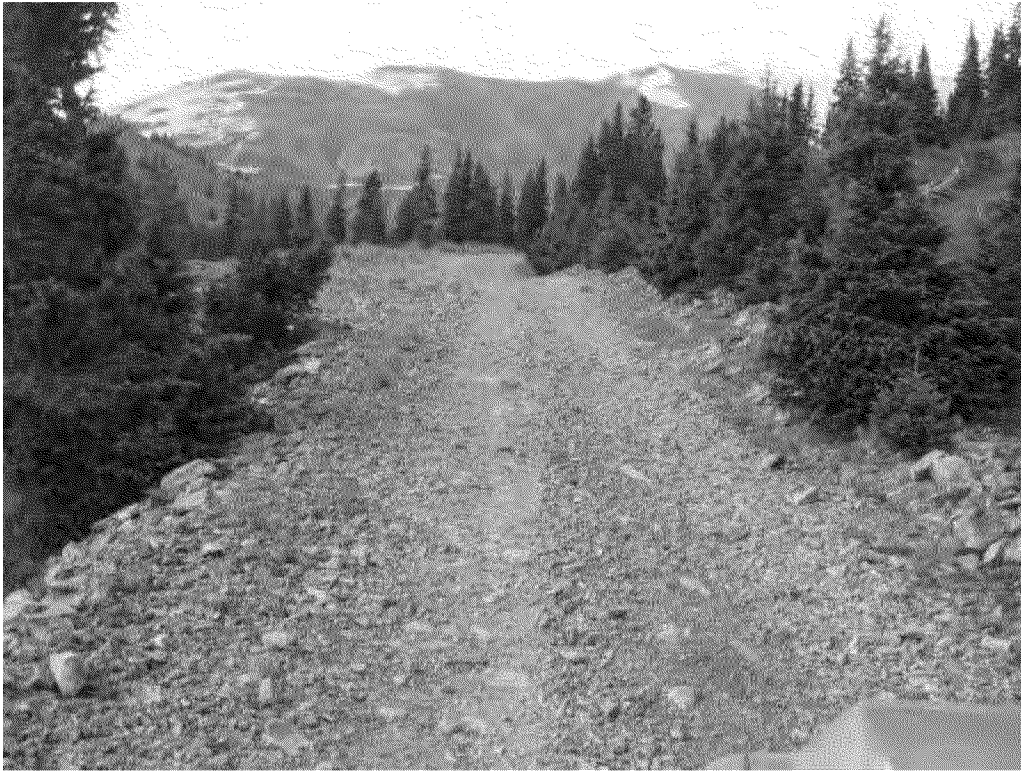
PHOTO 5 8-23-2011

Field conditions prior to adit entry activities. Northward view along CR53, north of mine site. See also Photo 6.

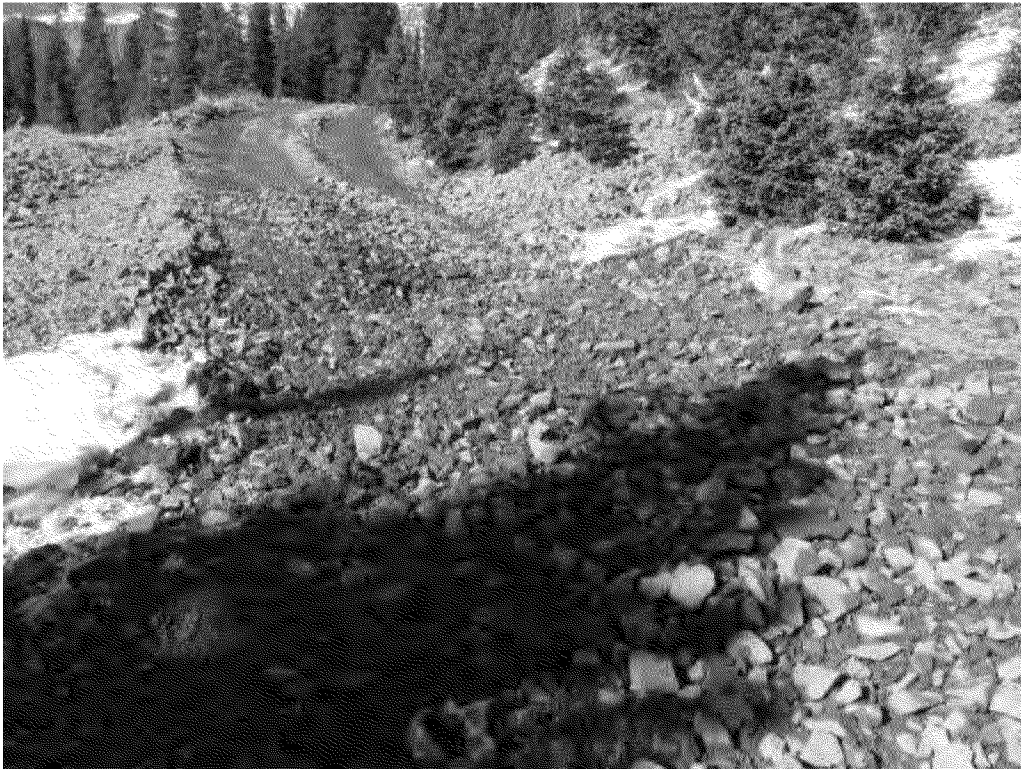
PHOTO 6 10-13-2011

Field conditions after adit entry. Water bar on CR53, north of mine site. North access road on level behind two trees on right. See also Photo 5.

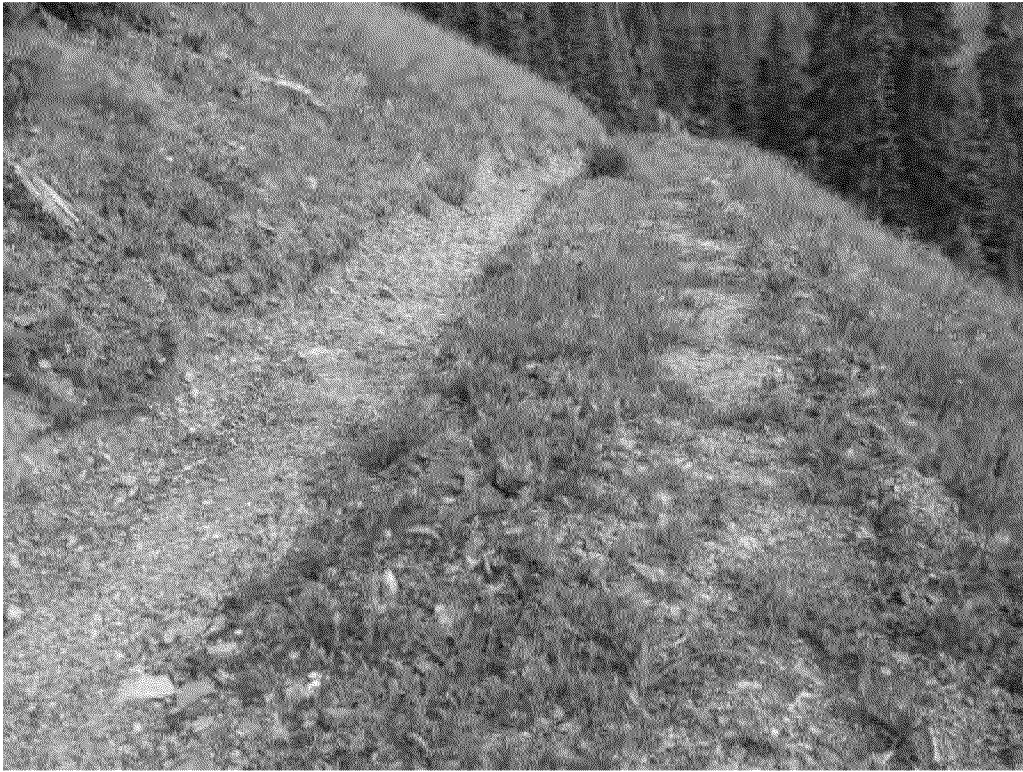
PHOTO 7 8-23-2011

Field conditions prior to adit entry activities. Southward view on north access road, south of gate. See also Photo 8.

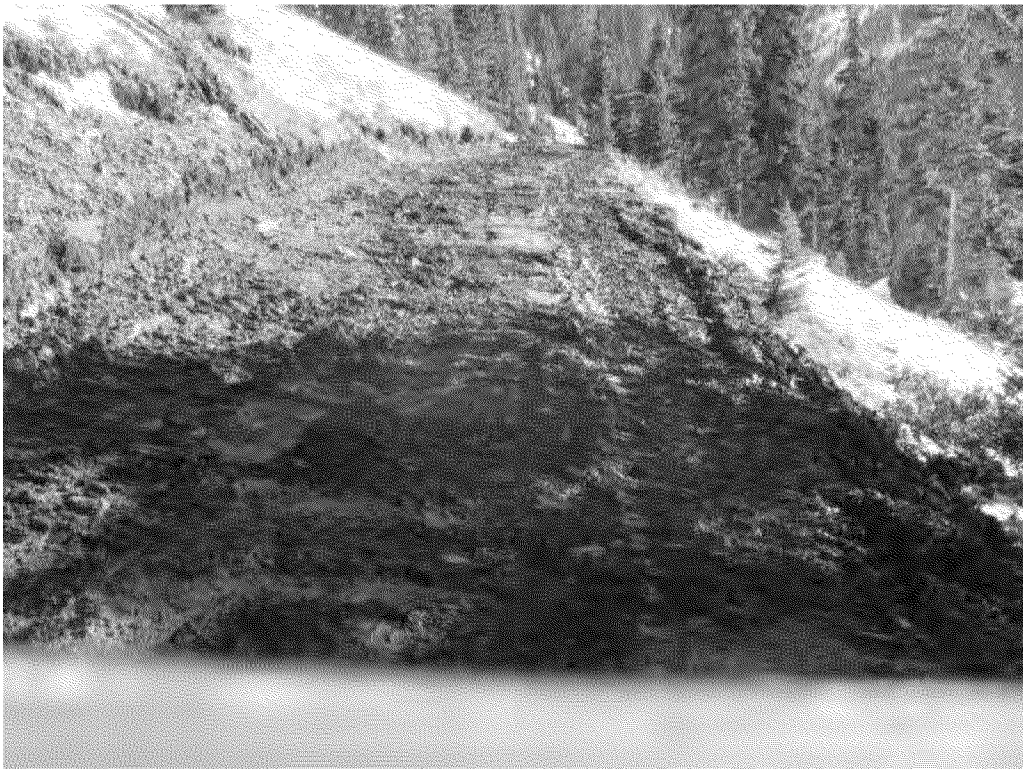
PHOTO 8 10-13-2011

Field conditions after adit entry. Southward view on north access road, south of gate. See also Photo 7.

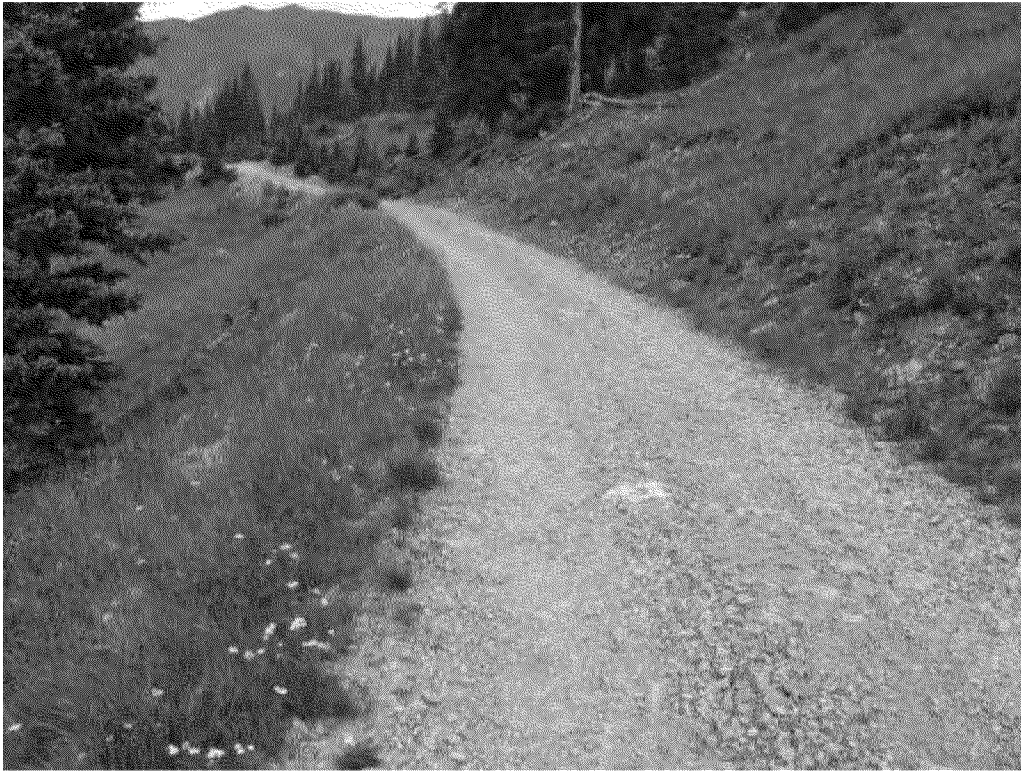
PHOTO 9 8-24-2011

Field conditions prior to adit entry activities. CR53 north of the mine, below the north access road intersection. See also Photo 10.

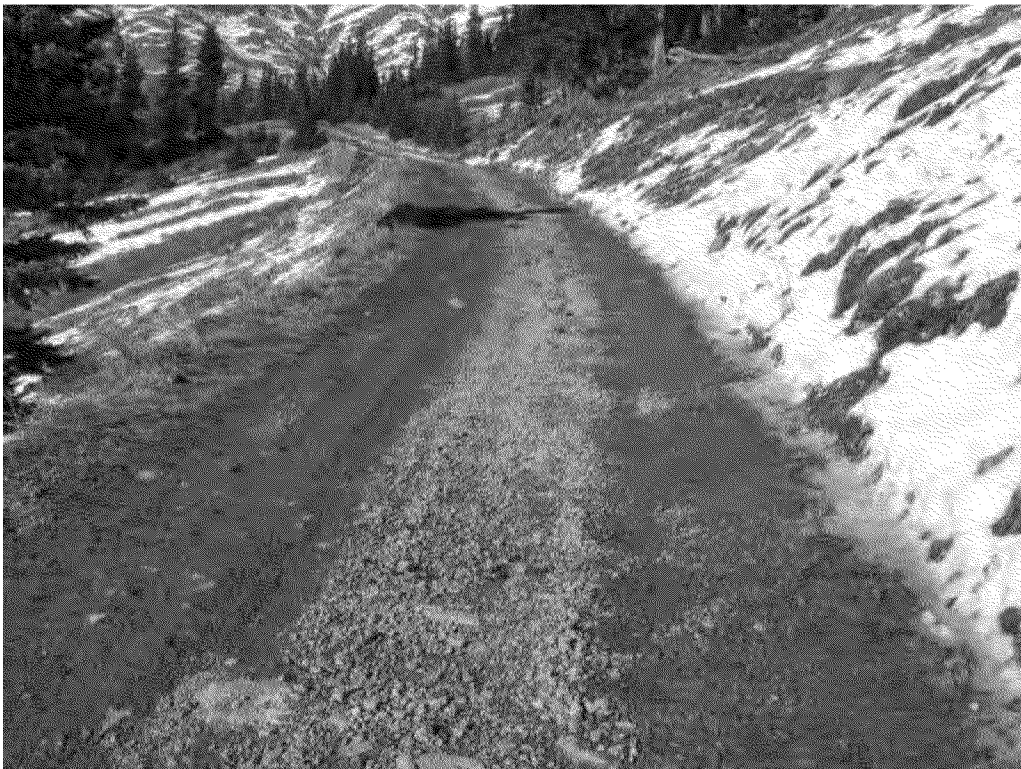
PHOTO 10 10-13-2011

Field conditions after adit entry. CR53 north of the mine, below the north access road intersection. See also Photo 9.

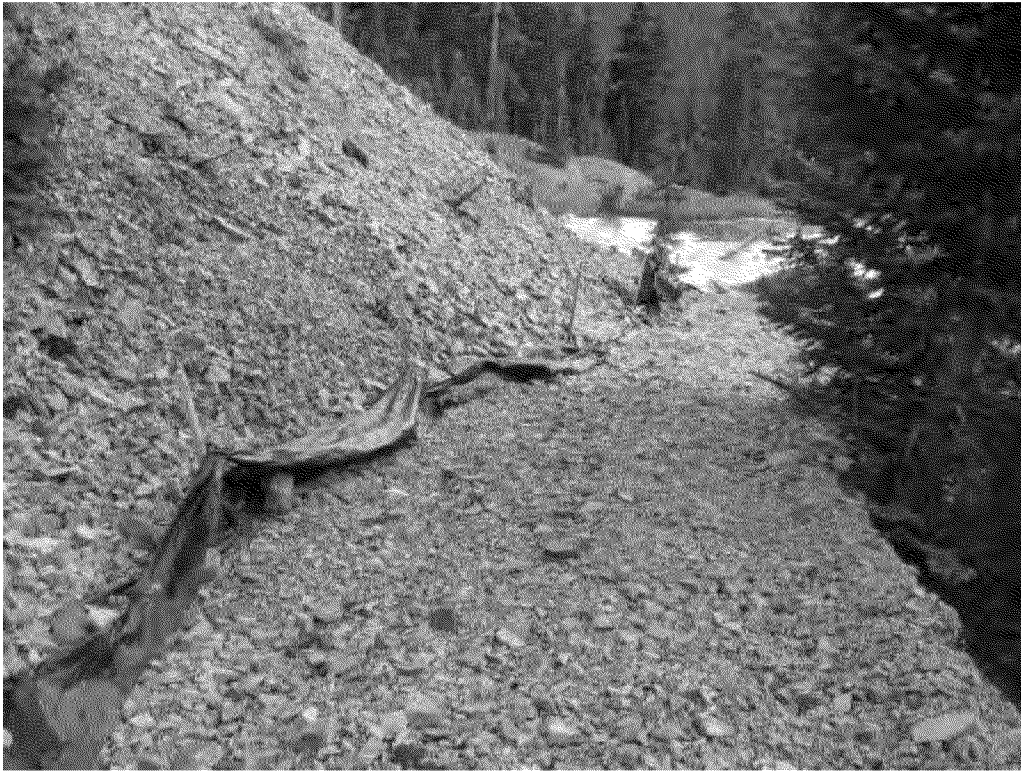
PHOTO 11 8-23-2011

Field conditions prior to adit entry activities. Top of mine dump visible at end of road.

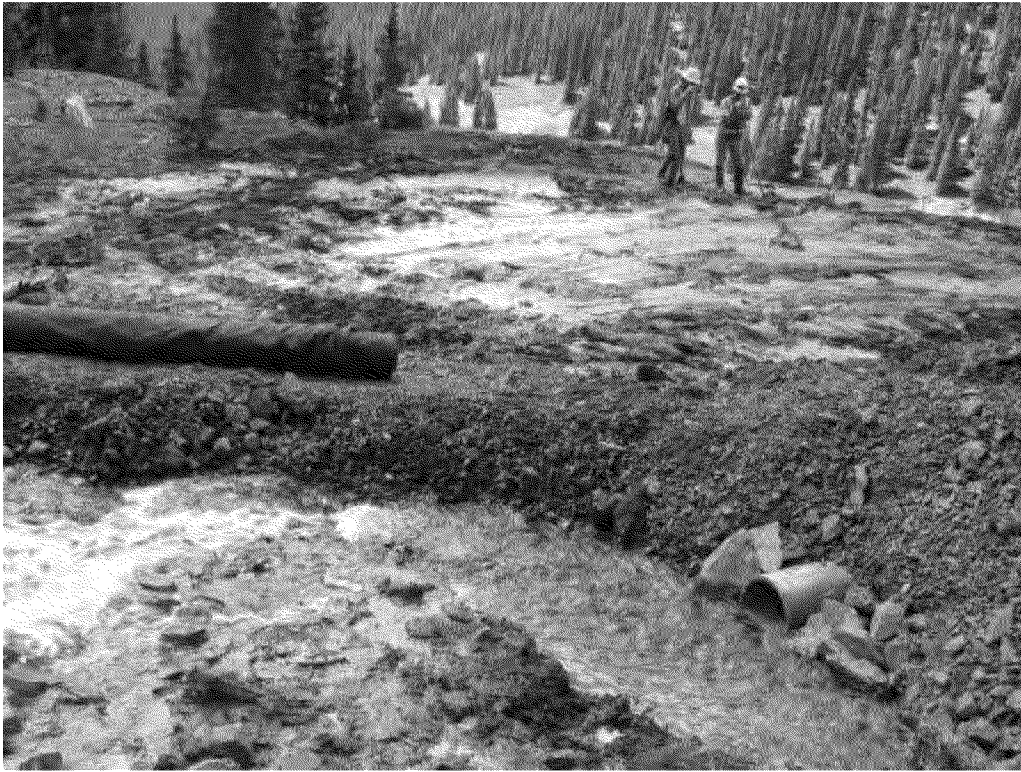
PHOTO 15 8-30-2011

Decanting water from yellow boy solids on dump surface. Temporary underflow pipe diverting adit water to north side of dump.

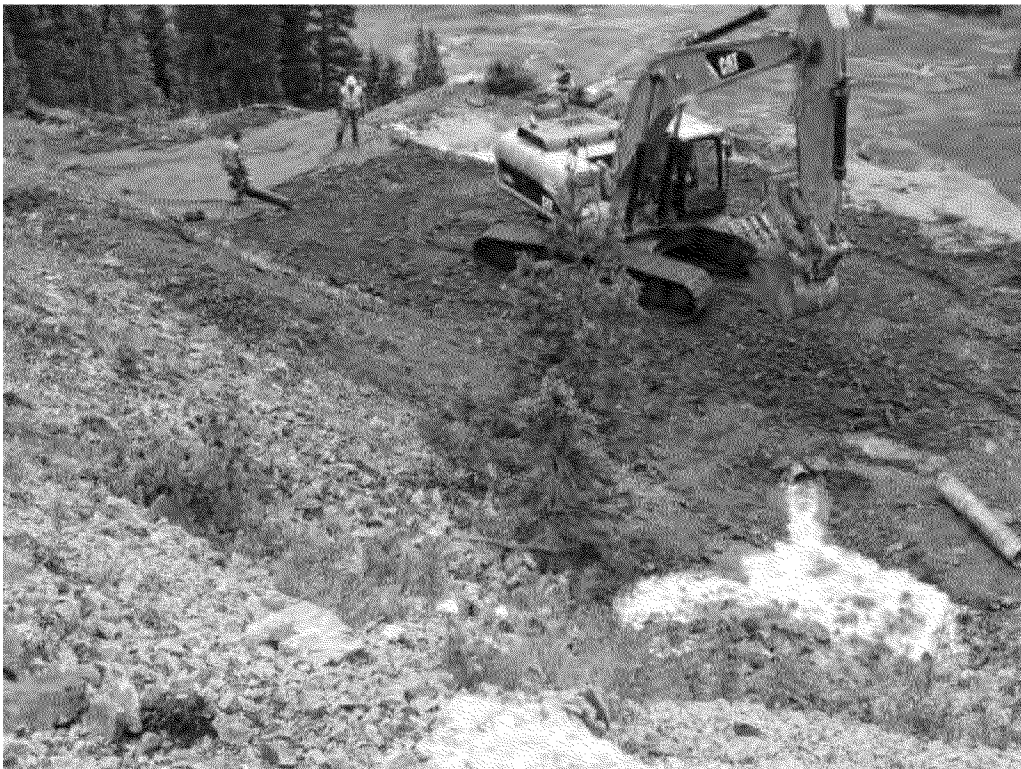
PHOTO 16 8-31-2011

Talus material placed over geotextile fabric that was placed over base talus material on dump surface. AMD discharge from collapsed portal in lower right, under-piped to south ditch. See also Photo 17.

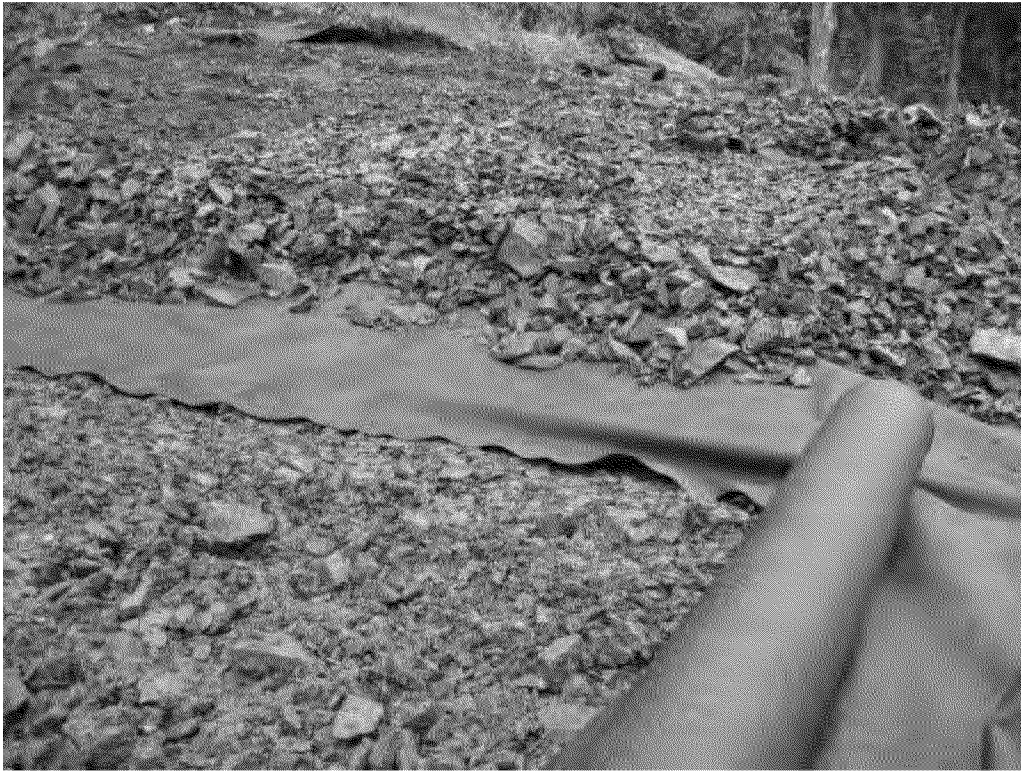
PHOTO 17 8-31-2011
Geotextile fabric placed between layers of talus material on mine dump.

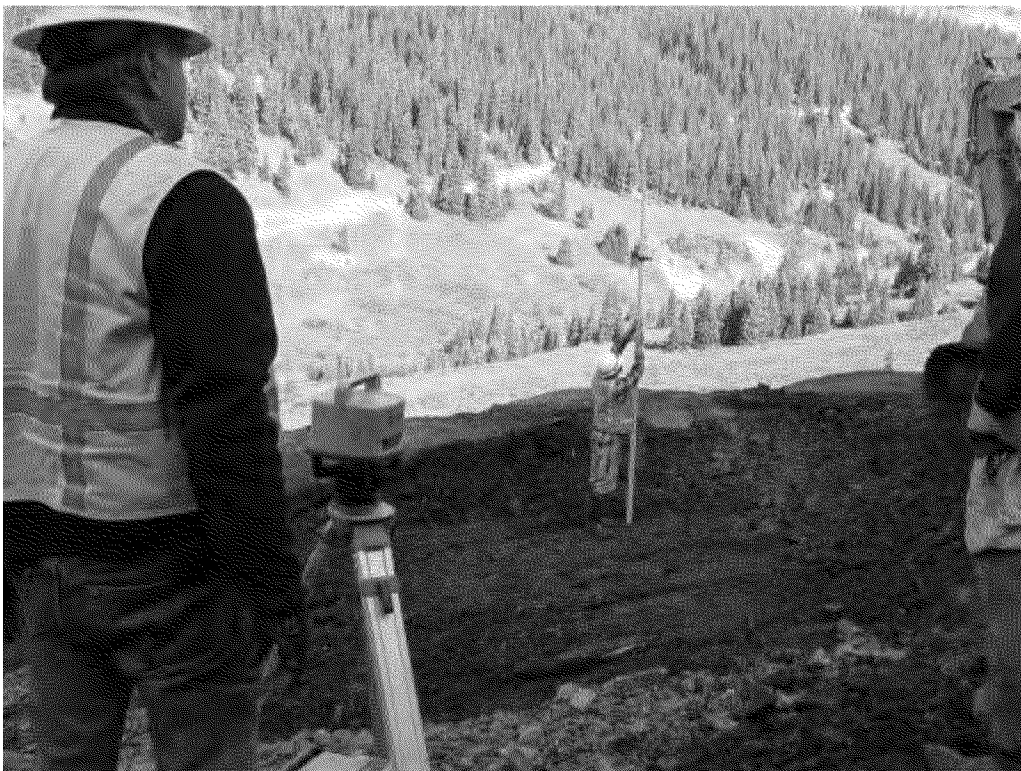
PHOTO 18 8-31-2011
Constructing pad for filter bag on dump surface.

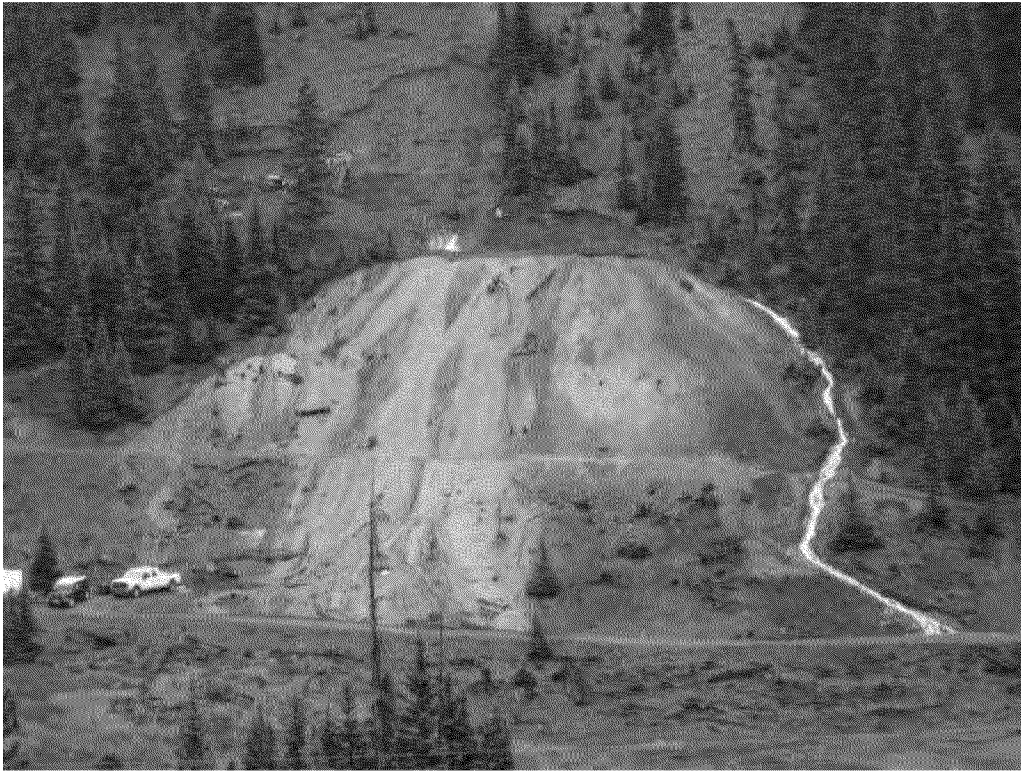
PHOTO 19 9-6-2011

Red and Bonita Mine. AMD cascading down portal collapse at top left of dump into the south ditch on right. Red and Bonita Mill debris in area on left side of dump above vehicles.

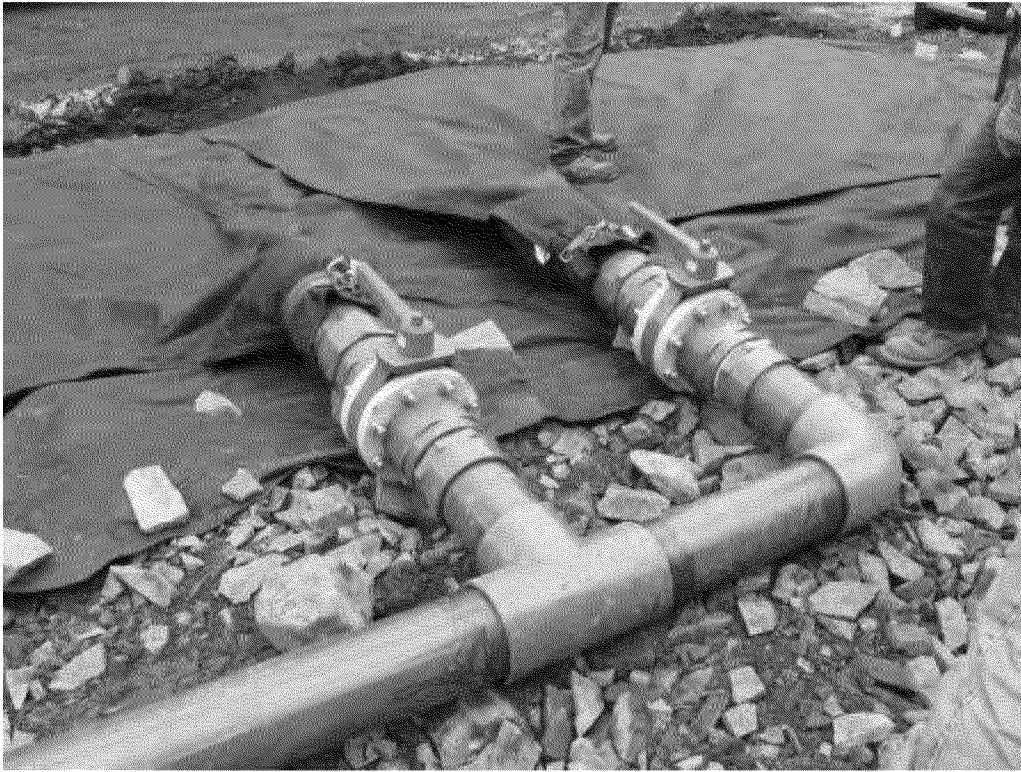
PHOTO 21 9-10-2011

Valve and filter bag manifold apparatus. Unused bags.

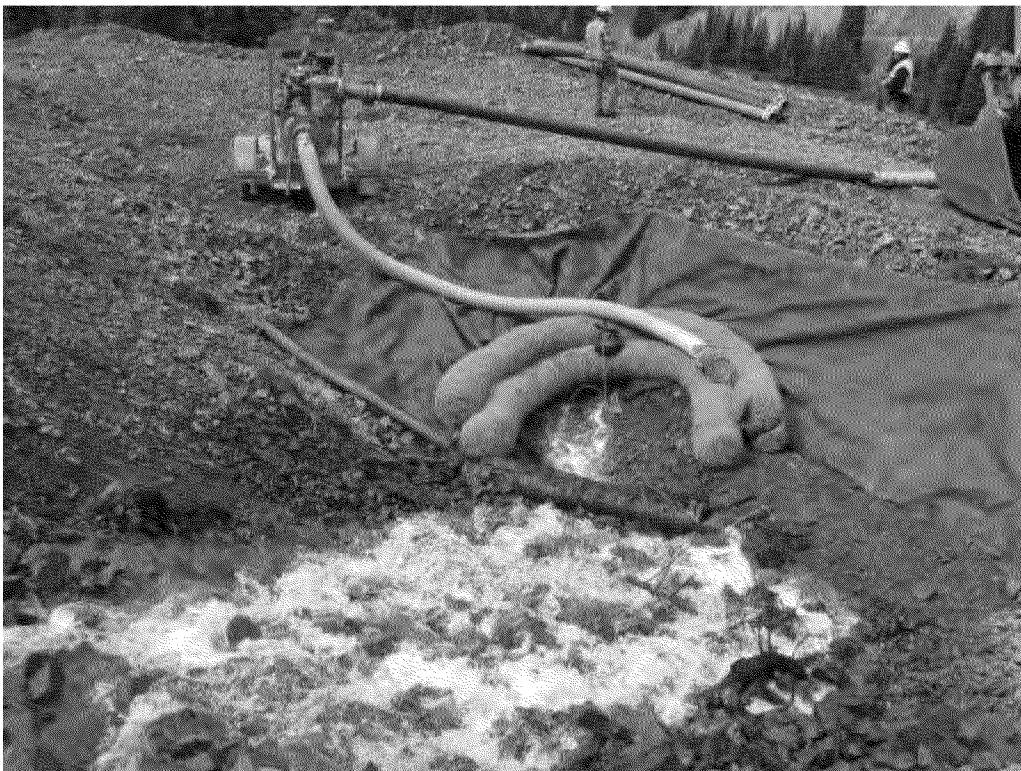
PHOTO 22 9-10-2011

Koir-Logs®, filter barrier, and pump at sump below the adit outflow. Twelve-inch PVC pipe under Koir-Logs® directs water to south ditch when not being pumped to manifolded filter bag apparatus at toe of dump. Pipe can be plugged with stopper, stored on Koir-Log® in photo center.

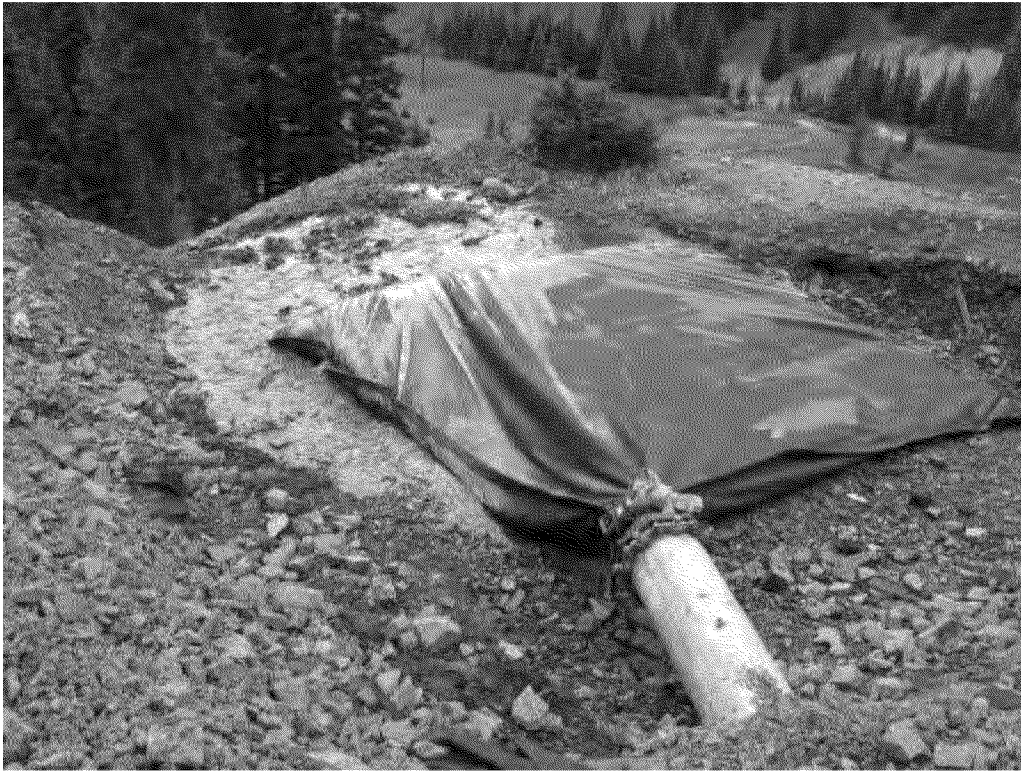
PHOTO 23 9-10-2011

Geotextile filter bag at diverted adit AMD outflow. Flowing into south ditch.

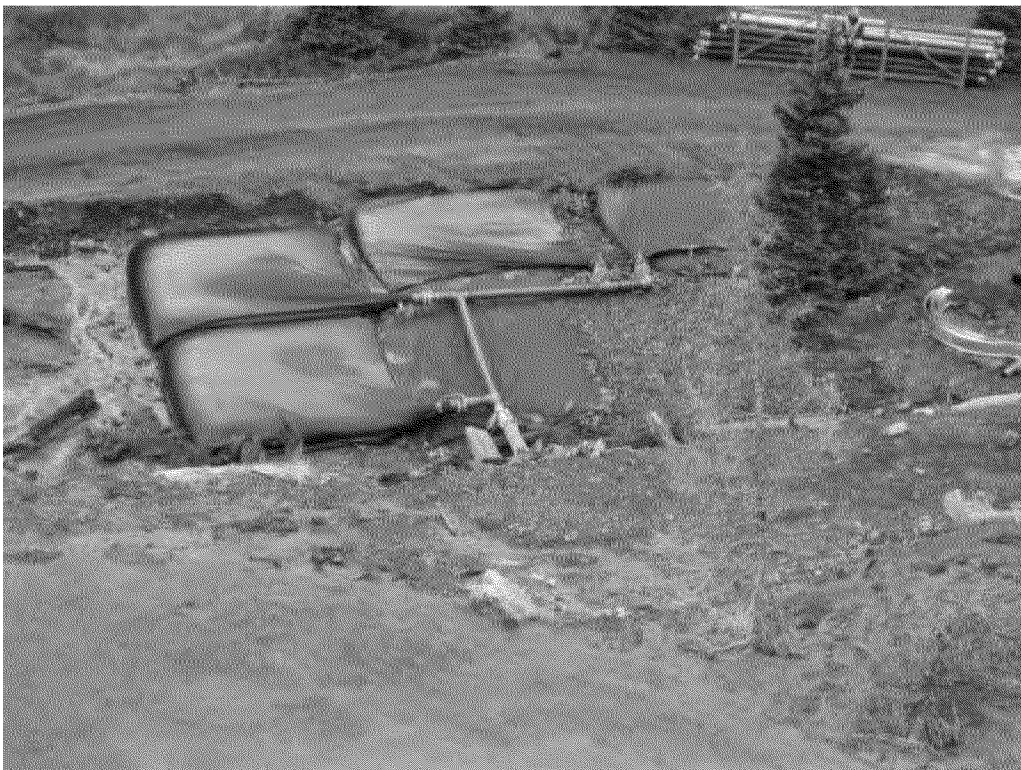
PHOTO 24 9-11-2011

- 2) During all active excavation activities at the collapsed mine portal, AMD effluent was pumped from the sump to a series of filter bags located at the toe of the dump (Photo 24). Flocculent was added to this flow to avoid plugging the filter fabric and to aid in dropping out solids inside the filter bag prior to releasing back into the road ditch system. Additionally, a filter bag was placed within the road ditch system at the outflow end of the culvert pipe located under CR53 before passing onto Cement Creek.

Geotextile fabric filter bags filtering AMD water at location below working surface at adit level. Flow releasing into road ditch system.

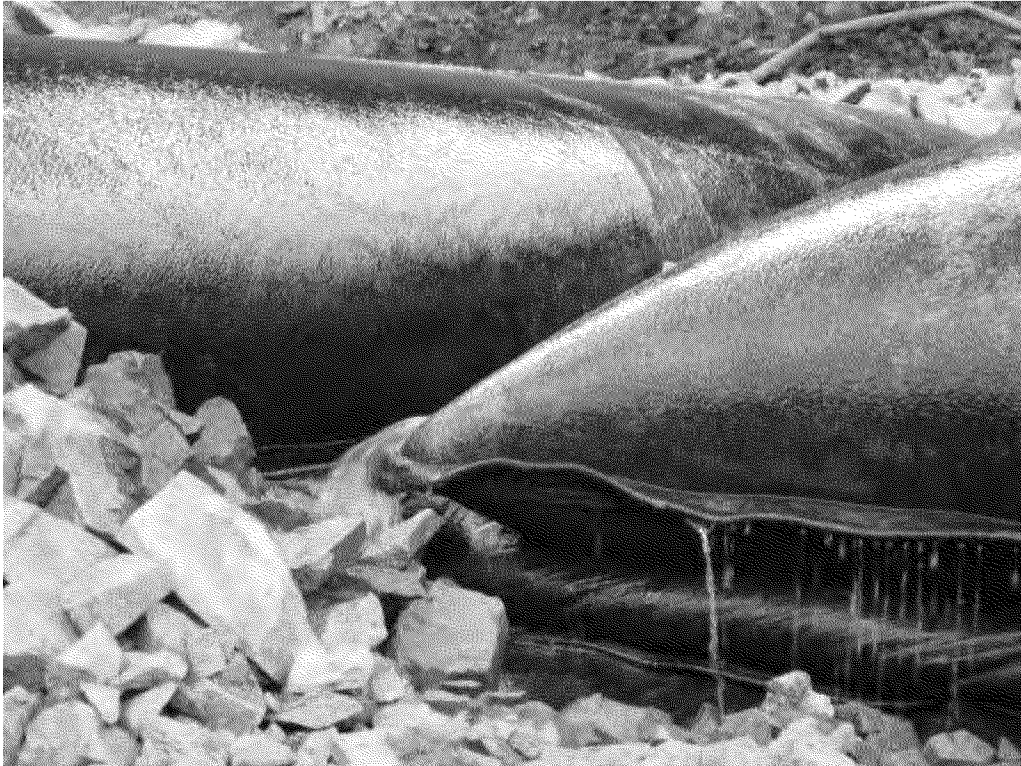
PHOTO 26 9-13-2011

Geotextile fabric water filtering bags passing filtered AMD water.

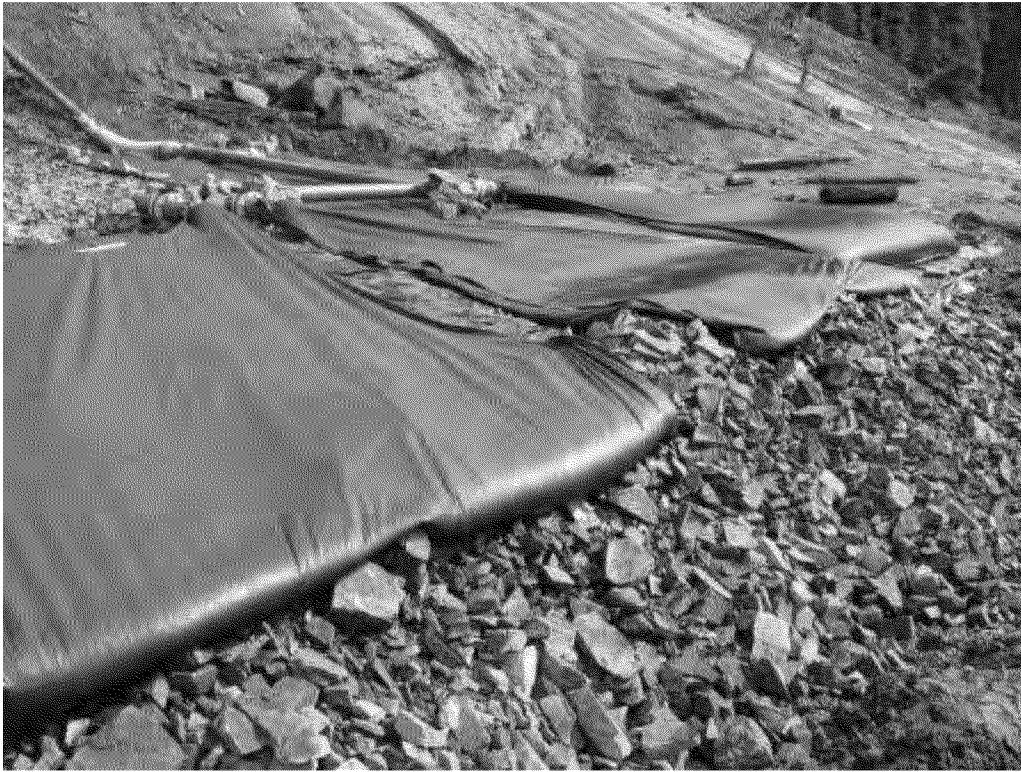
PHOTO 27 9-11-2011

Geotextile fabric filter bags at toe of mine dump slowly decanting after use.

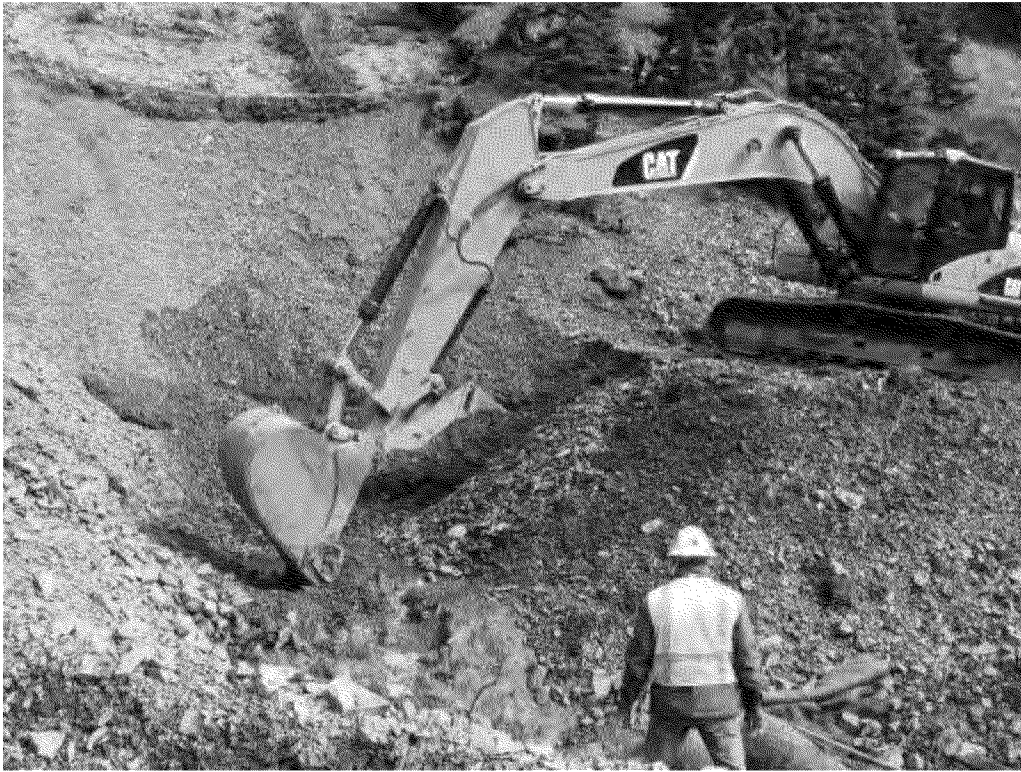
PHOTO 31 9-13-2011
Excavation activities at collapsed portal.

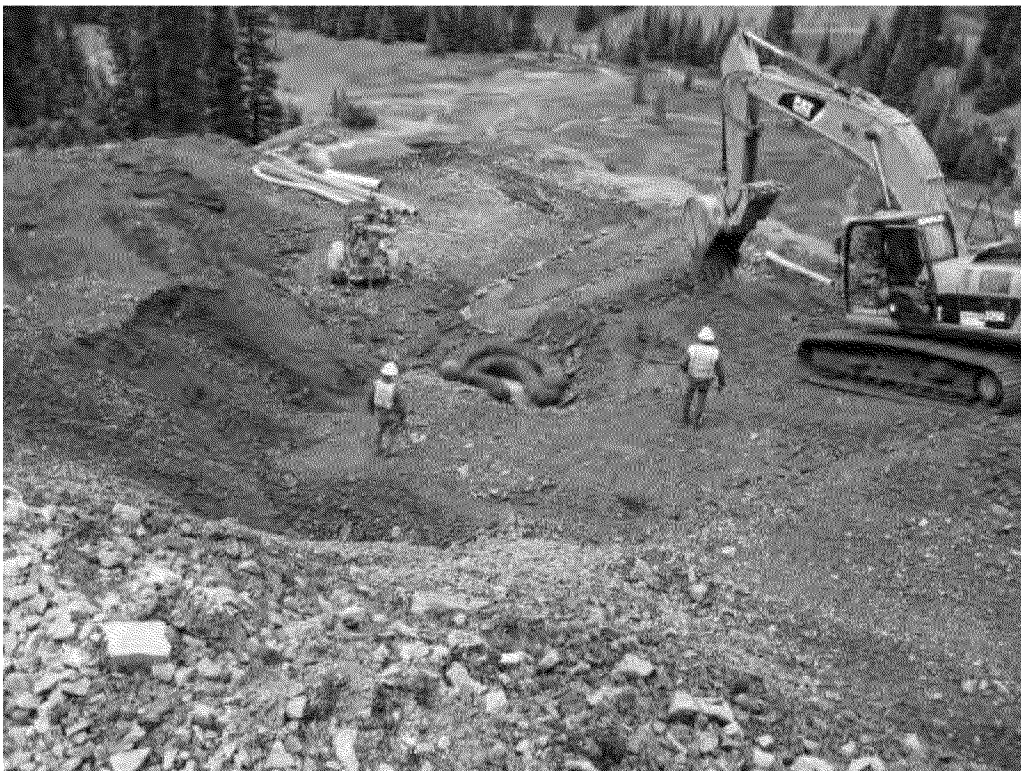
PHOTO 32 9-15-2011
View of operations on top of dump. Collapsed portal behind nearest workman's back out of view in foreground, AMD water flowing through temporary rock dam (nearest workman standing on) to sump where Koir-Logs® are located, under-piped to geotextile filter bag in background (behind stacked piping) where water is filtered prior to release to the south ditch out of view. AMD water flows through stressed vegetation zone in photo background to Cement Creek.

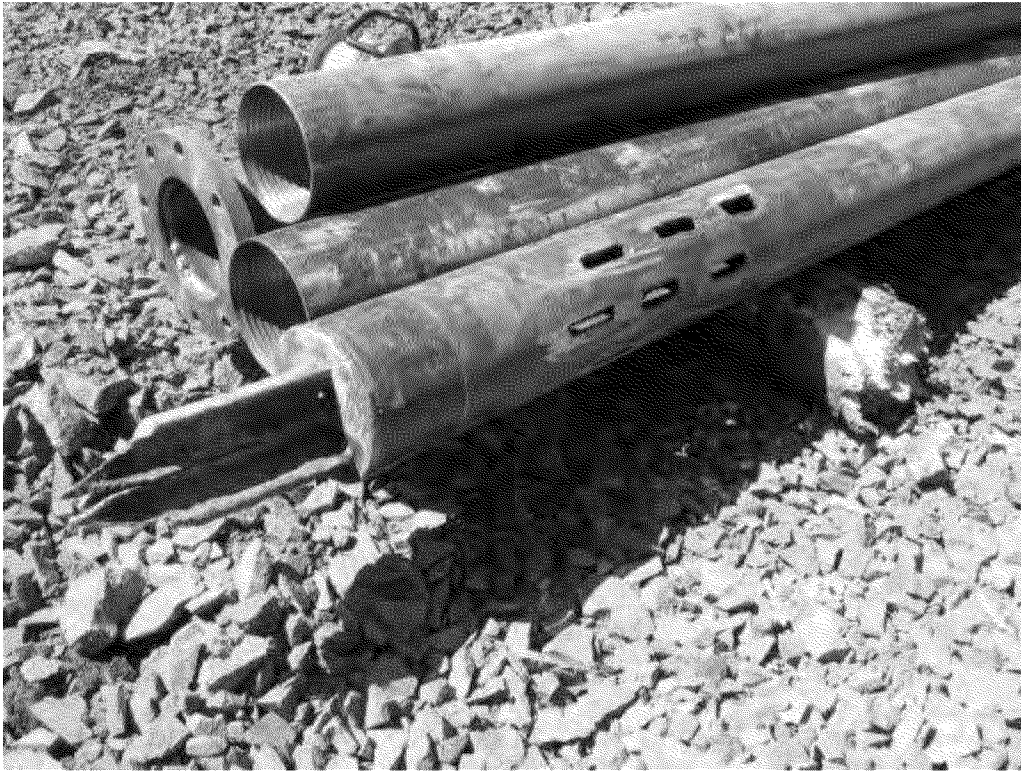
PHOTO 33 9-22-2011

Once the mine adit outline within competent rock was established by removal of much of the collapsed material, a 40-foot long, 6-inch diameter steel pipe was inserted into the mine adit through the remaining portal collapse (Photo 33). The pipe was used to pump water from the adit in order to reduce head pressure on the remaining portal collapse so additional excavation could be performed safely. The pumping rate through the pipe was monitored to gain insight regarding the potential of additional blockages inby of the mine portal by observing water extraction and recharge rates.

Schedule 40, 6.63-inch OD, flush-threaded steel pipe. Assembled during placement into mine adit. Used to pump AMD water from adit in controlled conditions.

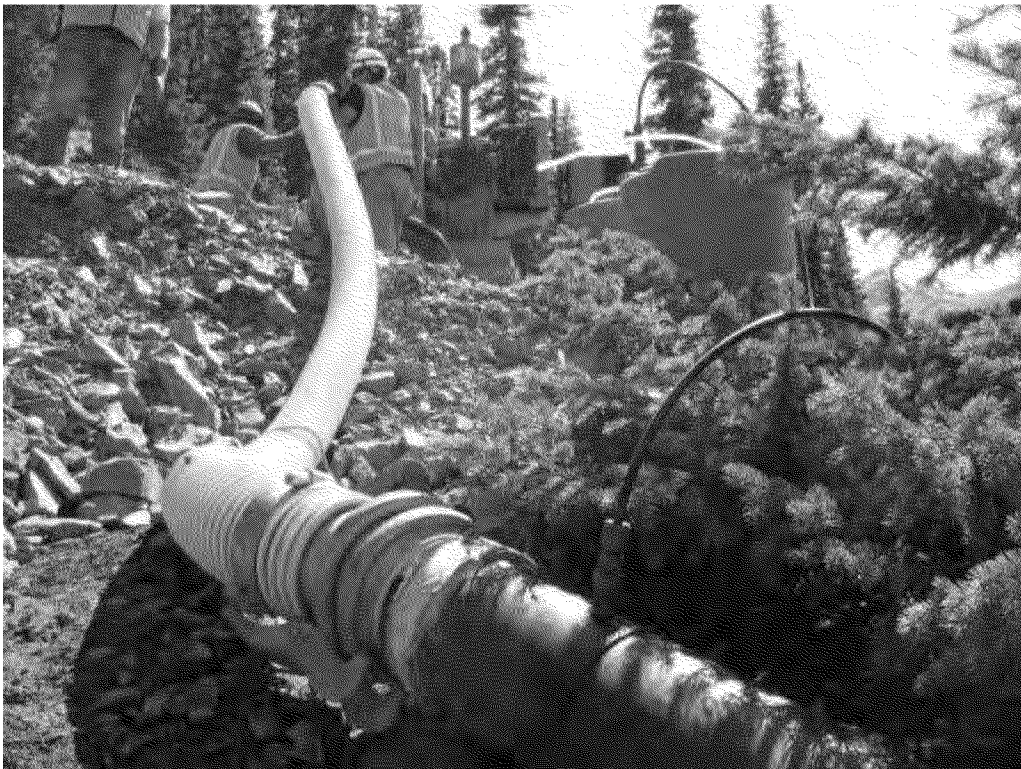
PHOTO 34 9-22-2011

filter bag could be adjusted to achieve uniform dispersion among the four filter bags. An aluminum sulfate flocculent was also added to the AMD water through tubing installed in the PVC piping at a point on top of the dump, allowing for thorough mixing within the piping prior to entry into the filter bags below (Photo 34). Flocculent was required to coagulate yellow boy fines into larger masses so as to not saturate the filter bag walls and cause a “blinding” effect that prevented water from draining. The liquid flocculent was metered into the PVC piping by a peristaltic pump at an approximate flow rate of 30 to 100 gallons per day (gpd), adjusted based on visual observation of filtered water releasing through the walls of the filter bags. Filter bags were replaced as needed. Spent filter bags do not pose any hazards and are currently safely stored at the site awaiting final disposition. AMD water analytical data is included on Tables 4 and 5.

Liquefied aluminum sulfate flocculent pumped from blue poly drums (photo right) into drain pipe directing flow to geotextile fabric filter bags located at dump toe.

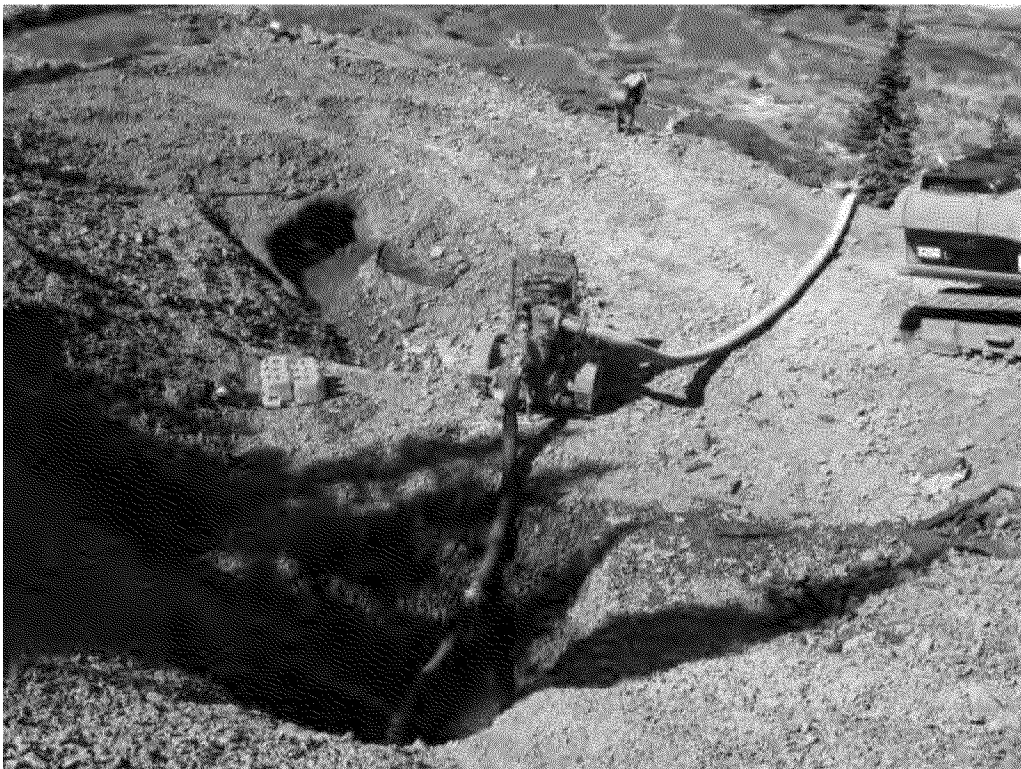
PHOTO 36 9-27-2011

AMD water pumping operations from steel pipe in adit. Water is piped to geotextile fabric filter bags located at toe of mine dump.
